**Final report to the Thomas Smythe Foundation, Inc. : concerning
geophysical reconnaissance of a portion of the area offshore
from Jamestown Island, Virginia**

GEOPHYSICAL RECONNAISSANCE
OF A PORTION OF THE AREA OFFSHORE FROM
JAMESTOWN ISLAND, VIRGINIA

Carl H. Hobbs, III
Department of Geological and Benthic Oceanography
College of William and Mary
School of Marine Science
Virginia Institute of Marine Science
Gloucester Point, Virginia 23062

April, 1991

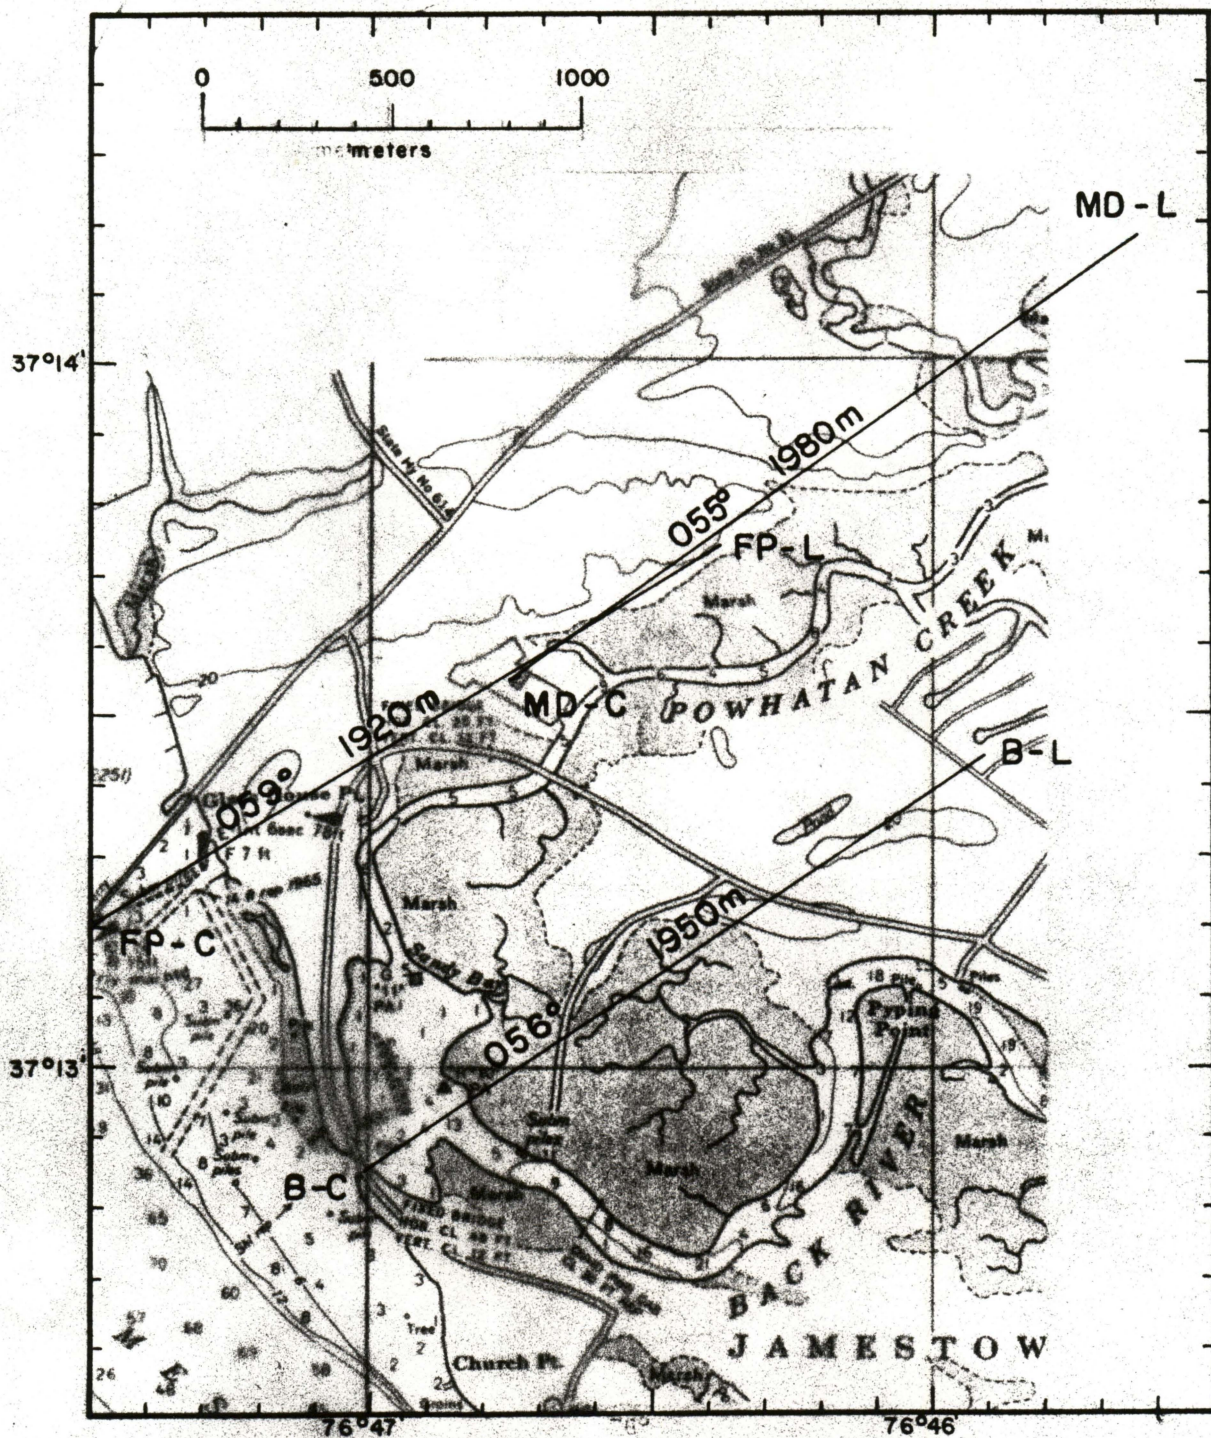
APPENDIX 4: Plot of loran and real positions of sites listed in Appendix 3. (next page)
